# Operating Experience Weekly Summary 99-24

June 11 - June 17, 1999

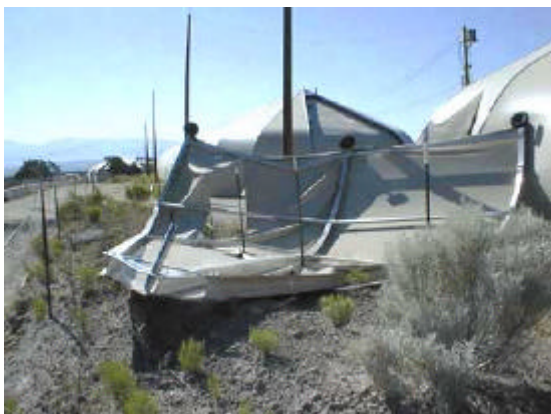
**Figure 4-1. Damaged Door**

On June 9, 1999, at the Los Alamos National Laboratory Waste Management Facility, a radiological control technician (RCT) discovered that a 30-ft by 25-ft sliding door to a waste storage dome had been blown off. The door was severely damaged and two panels on the north side of the dome were also torn. The waste drums inside, which contain transuranic waste, were not disturbed. The RCT verified that all radiological postings were still in place and conducted a survey of the controlled area within the dome using a hand-held monitor. No activity was detected. Local maximum wind velocity was 31.8 mph and an instantaneous gust measurement taken at a meteorological station 1 km southeast of the area recorded 47 mph. The initial estimated replacement cost is \$50,000. Although there was no impact on health, safety, or the environment, damage to waste storage domes and tents could expose radioactive waste containers to the environment. (ORPS Report ALO-LA-LANL-WASTEMGT-1999-0005)

Investigators determined that the door appeared to have been blown open at the southeast side or corner of the doorframe and been picked up by a strong gust of wind and to have lifted and landed on the roof of the dome. It then pulled loose of the pivot hinge and slid down the northeastern side of the dome, as is evident from the rubber marks on the side panels made by the door tires. The door eventually landed approximately 30 ft from the door opening, and a cross member of the door assembly landed approximately 35 ft from the opening of the door. Investigators believe the door was not latched closed on June 8. If the doors are not tightly shut there can be as much as a 2-in. gap. They believe that under the right conditions this small gap could allow the wind to push the door open enough for the wind to get behind it and an event such as this to occur.

Facilities-Solid Waste Management personnel inspected all other domes to ensure that they were secure. Any domes without latches will have external latches installed to make it easy to verify that the doors are latched. Personnel also rebuilt the damaged door frame so that the dome could be properly secured.

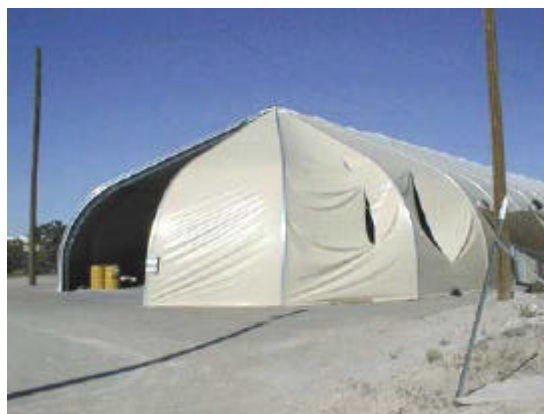
**Figure 4-2. Dome with Damaged Panels**

Figure 4-1 shows the damaged door and figure 4-2 shows the door location and the damaged panels.

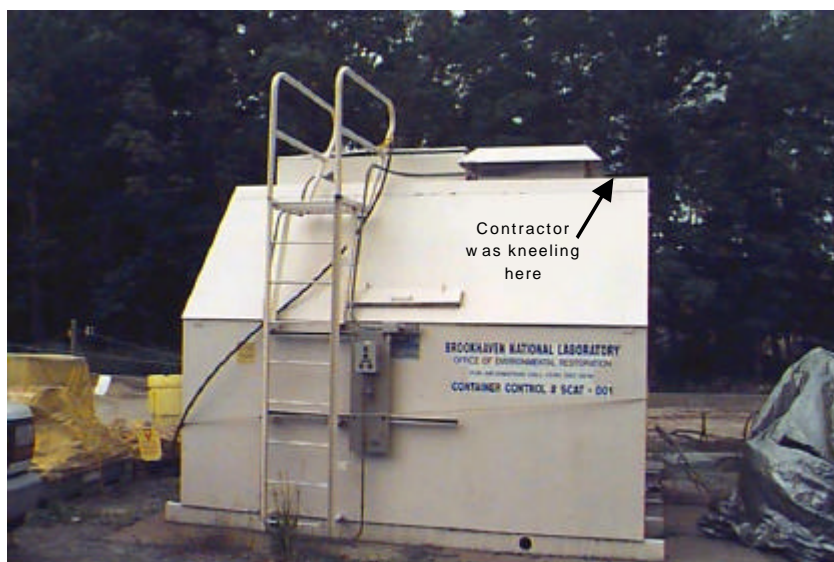
**Figure 5-1. Storage Tank Configuration**

The SCAT measures 12 ft long by 10 ft wide and 9 ft high. It has a fixed ladder that goes to a small (fall-protected) platform on top from which the tank ports can be accessed. Only the platform at the top of the ladder is fall-protected; the remainder of the tank is not designed to be occupied. Figure 5-1 shows the tank arrangement and location of the contractor before he fell.

Investigators determined that while the worker was on the tank, he held on to a vent pipe mounted on top of the tank as he reached for the hose. The vent pipe broke from its fitting, and the worker lost his balance and fell to the ground. He was fortunate that he did not land on top of the filtration system located next to the SCAT. Investigators also determined that the only way to pipe water from the SCAT to the filtration system was to attach hoses at the top of the tank. However, the contractor worker did not have to leave the fall-protected area to be able to do that. No fall protection was used other than the railings provided at the ladder and platform.

The project manager conducted a critique of the event. Critique members determined that poor work planning was a contributing cause, because elevated work areas were not identified as a potential safety concern before the job began. Managers are evaluating the job for improvements, and it will not continue until an appropriate method for attaching hoses to the tank has been determined.
